Notice Sheet 5

Tech Note 75 - Technical Information (Slave Cylinder) Holden / Isuzu

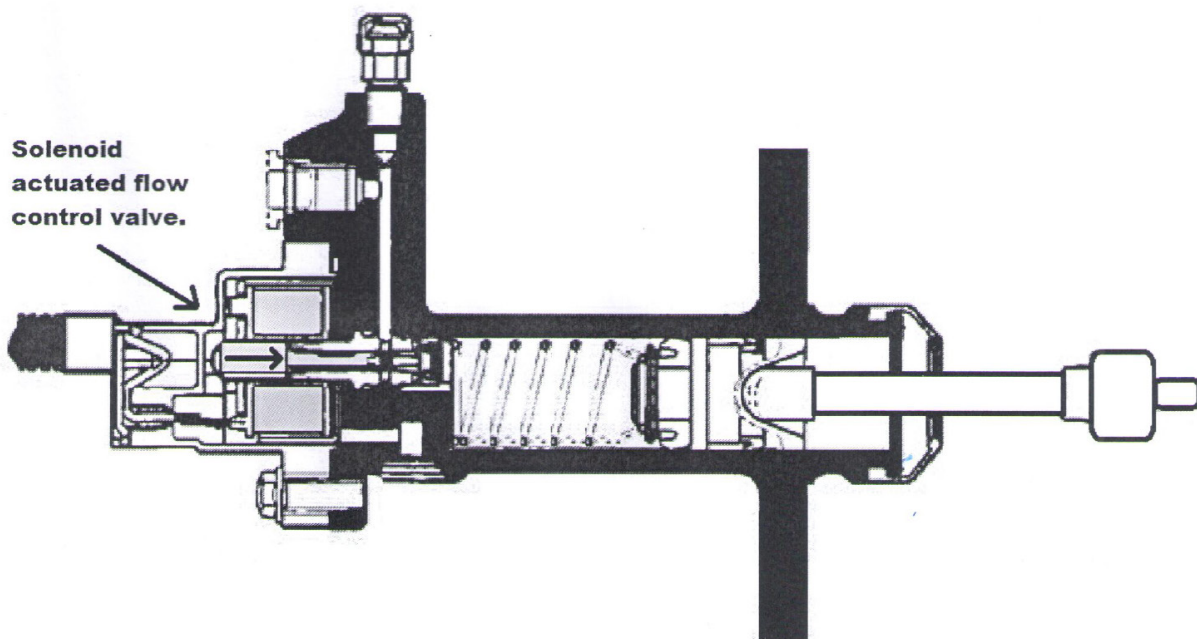
It has been found that the solenoid fitted to the rear of the clutch slave cylinder in these vehicles can often fail, therefore restricting the flow of hydraulic fluid to and from the master cylinder.

Failure to check for or replace a faulty slave cylinder may result in clutch slip, clutch non-release and premature clutch failure.

Replacement cylinders can be purchased from your EXEDY distributor, part number to order CS001.
