Notice Sheet 13
Ford Ranger/ Mazda BT50 Clutch Damper

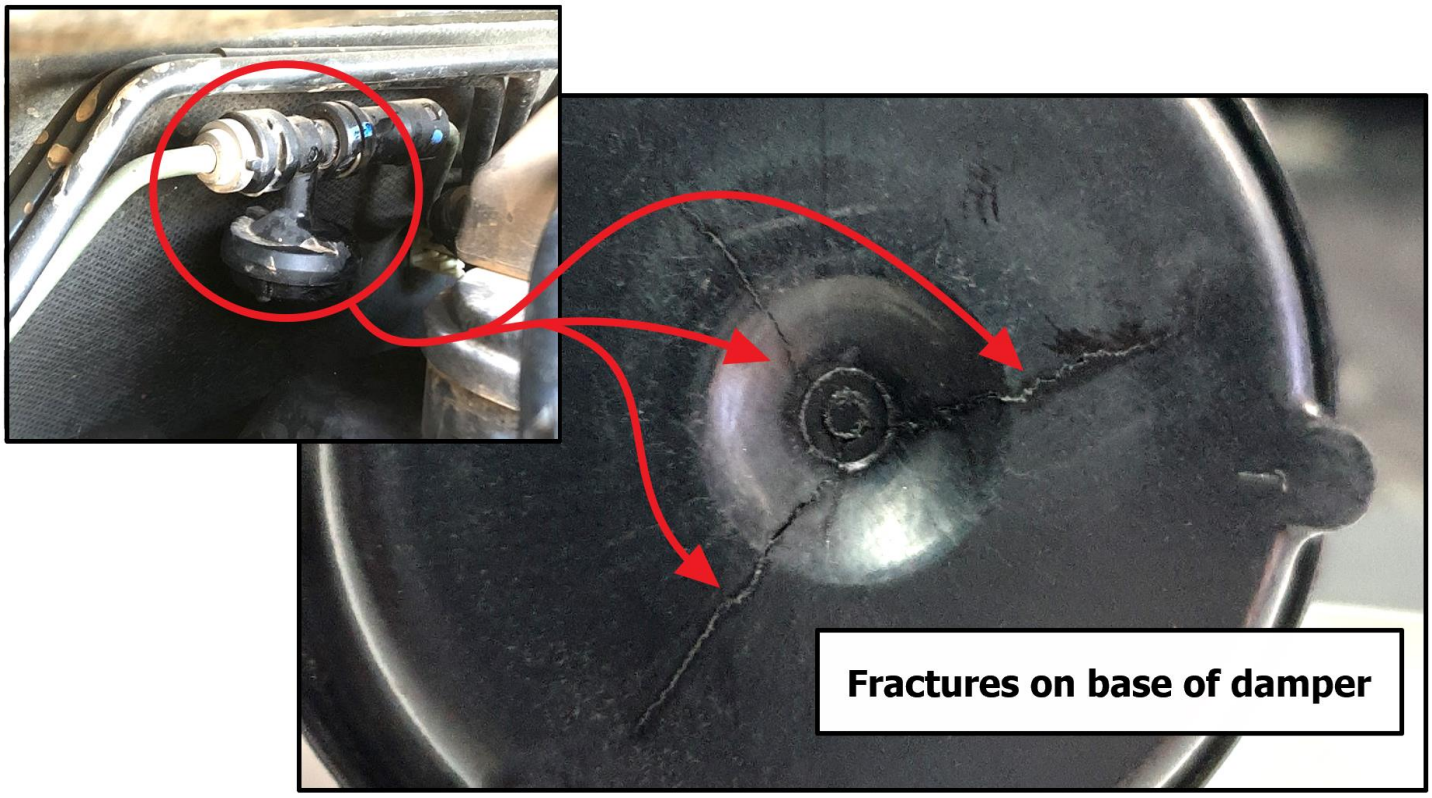
The hydraulic clutch damper located on the firewall (circled in the image below) can perish over time and close inspection of the damper is required at the time of clutch fitment.

Failure to identify or replace faulty clutch damper may result in loss of pedal pressure and/or difficult gear selection.
